ANALYSIS AND CONSOLIDATION OF ARCHITECTURAL PLASTERS FROM ÇATALHÖYÜK, TURKEY

A THESIS

Historic Preservation

1996

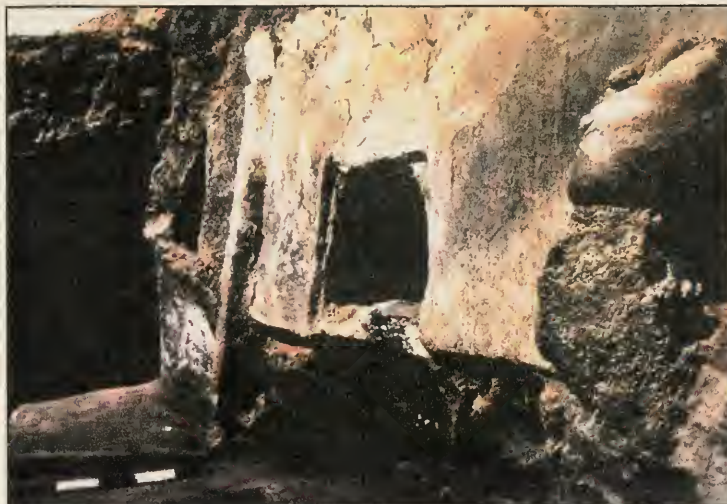
Figure 6: Photograph of the east wall of Shrine VI.A.7, showing plastered walls and reliefs. From Mellaart, James. *Çatal Hüyük, A Neolithic Town in Anatolia*. New York: McGraw-Hill Book Co., 1967.

Some of the rooms constructed of the same materials with a comparable plan can be differentiated by such features as plaster reliefs, wall paintings, cattle horns set into benches, rows of bucrania, and *ex-voto* figures. (Figure 6). Mellaart has interpreted these more elaborate building units as shrines.⁶ A total of 48 shrines were identified in the excavated portion of Çatalhöyük, with 15 more probable or possible shrines, out of a total of 166 rooms.⁷

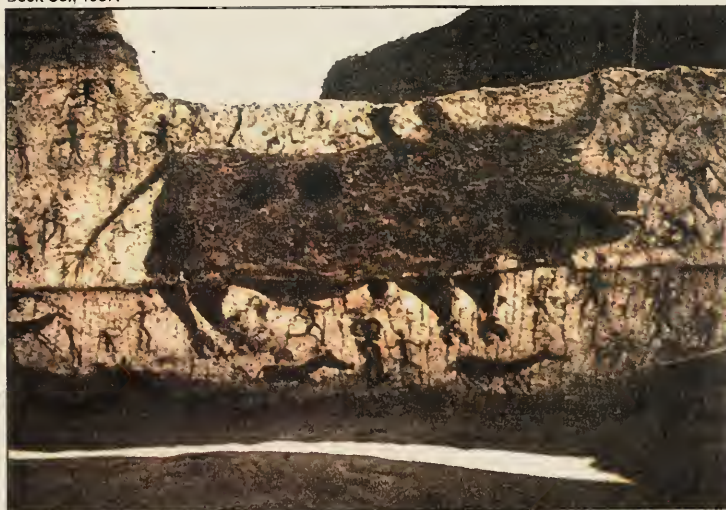
Figure 7: Photograph of a bull wall painting. From Mellaart, James. "Çatal Hüyük—The World's Oldest City." *Illustrated London News*, 28 May 1966, 26-27.

In addition to the impressive plaster reliefs at Çatalhöyük, the floors and walls of the houses and shrines were covered with plaster. Applied as smooth layers on vertical and horizontal surfaces, these plaster layers were sometimes painted but most often left undecorated. (Figure 7). Although often unpainted, the plaster might have served a decorative function by enhancing the interior environment of the rooms. It also had a pragmatic role, intended or not, protecting the mud brick from elements of weathering. The many layers of plaster indicate that it was often replaced, perhaps with ritual significance.

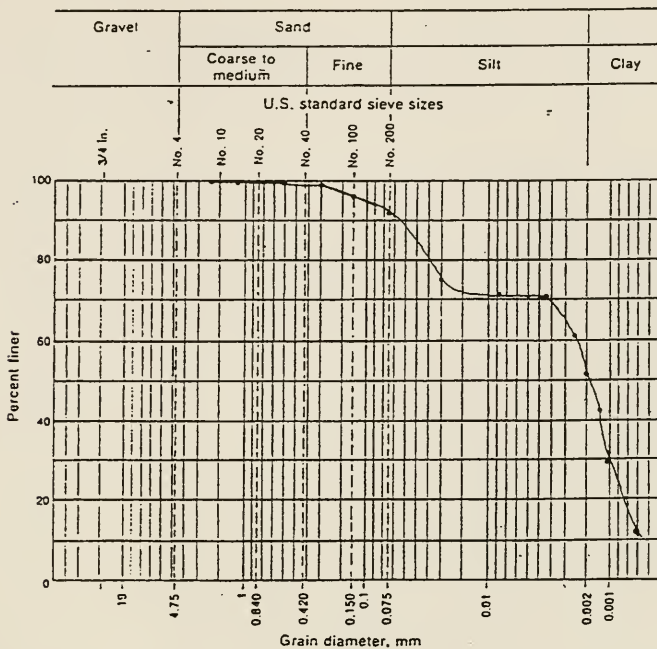
Figure 8: Particle size distribution of a wall plaster (Sample C). The wall plaster is predominantly composed of silts and clays with very little sand-size particles.

In both the wall plaster and relief plaster samples, almost all of the component particles are fine sands or smaller, with roughly 90% of the plaster being silts and clays, as determined by dry sieving. Wet gravimetric analysis indicates that the proportions of silts to clays in the two types of plasters differs significantly, however. Most of the very fine material in the relief plaster are silt-size particles. Only approximately 10% of the sample consists of clays. On the other hand, almost 50% of the particles making up the wall plasters are clays, with 30% being silts.

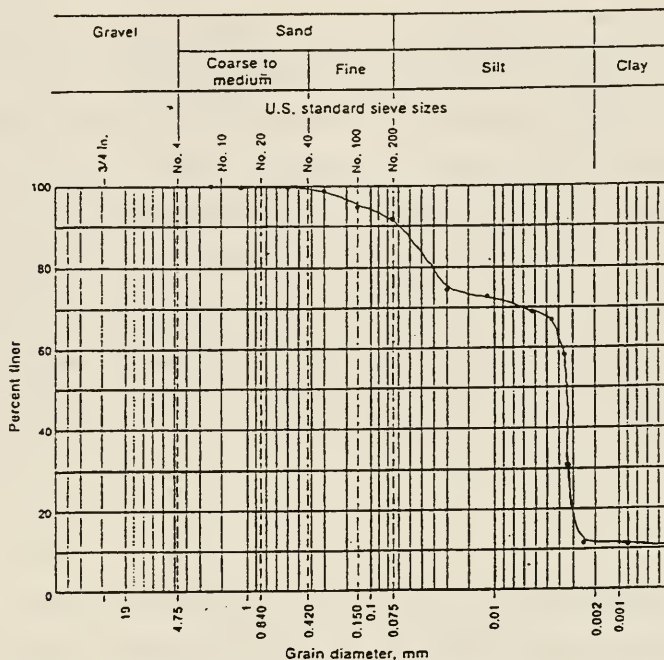
Figure 9: Particle size distribution of a relief plaster (Sample B). The relief plaster has relatively few sand-size particles, like the wall plaster sample, but has fewer clay-size particles than the wall plaster.

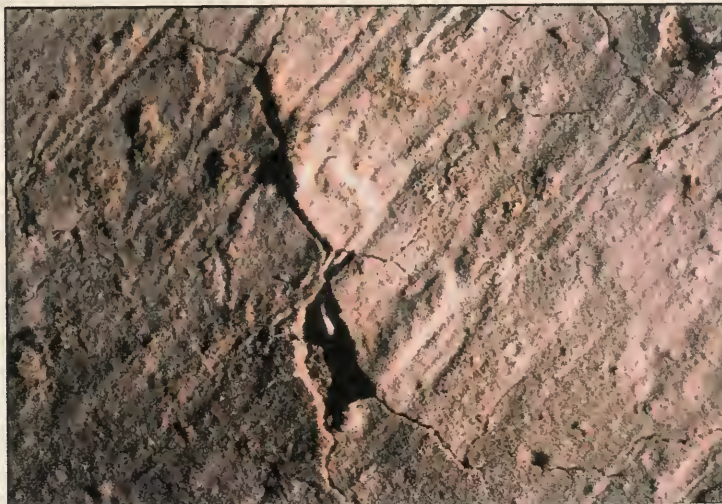
Figure 10: Photomicrograph of Sample A showing brush marks at 25x magnification under quartz halogen illumination. The brush marks run diagonally across the photomicrograph.

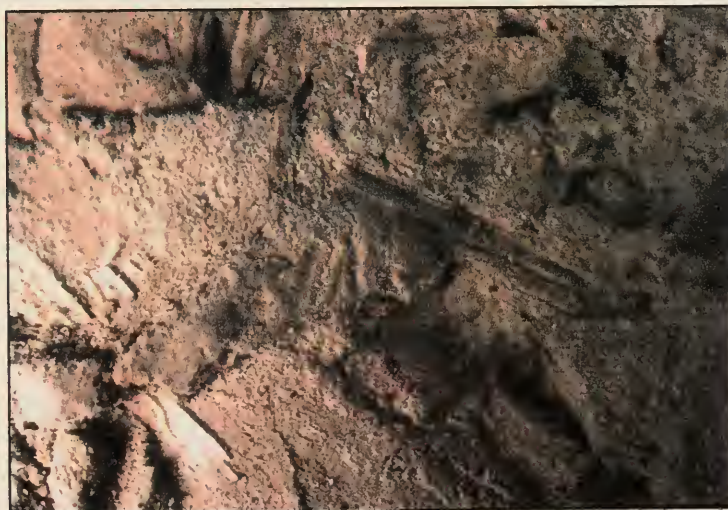
Figure 11: Photomicrograph of Sample A showing fiber impressions at 25x magnification under quartz halogen illumination.

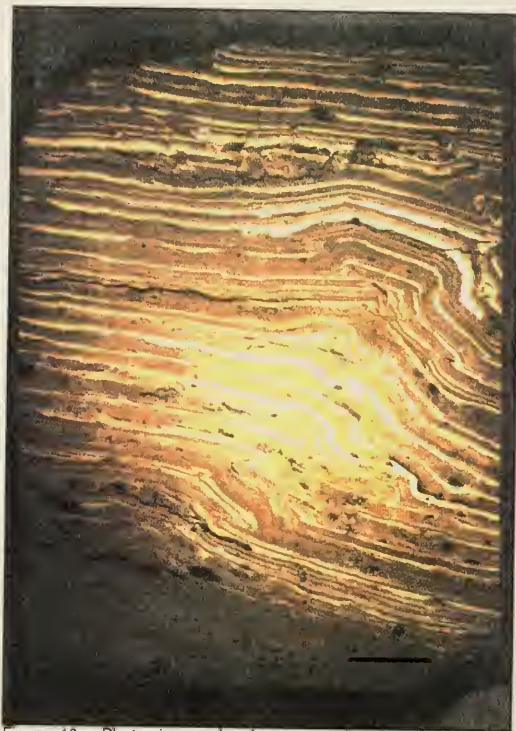
Figure 12: Photomicrograph of cross section A₁ showing full stratigraphy at 5x magnification under quartz halogen illumination. The bar equals 0.5 cm.

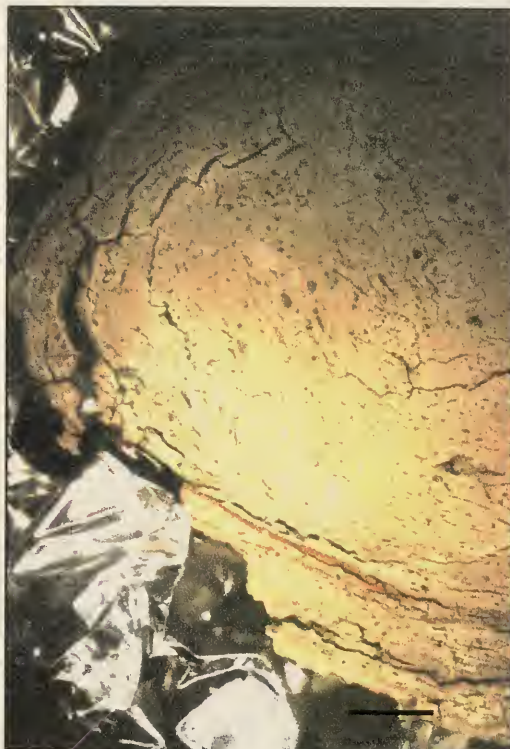
Figure 13: Photomicrograph of cross section B₁ showing full stratigraphy at 5x magnification under quartz halogen illumination. The bar equals 0.5 cm.

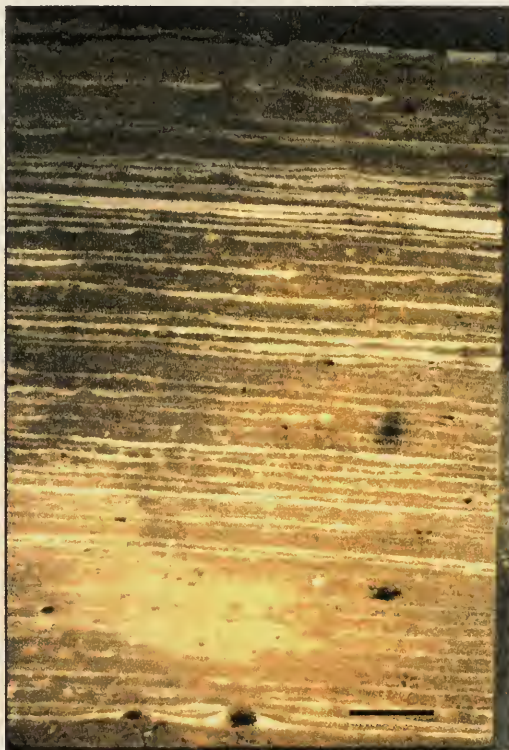
Figure 14: Photomicrograph of cross section C₁ showing full stratigraphy at 5x magnification under quartz halogen illumination. The bar equals 0.5 cm.

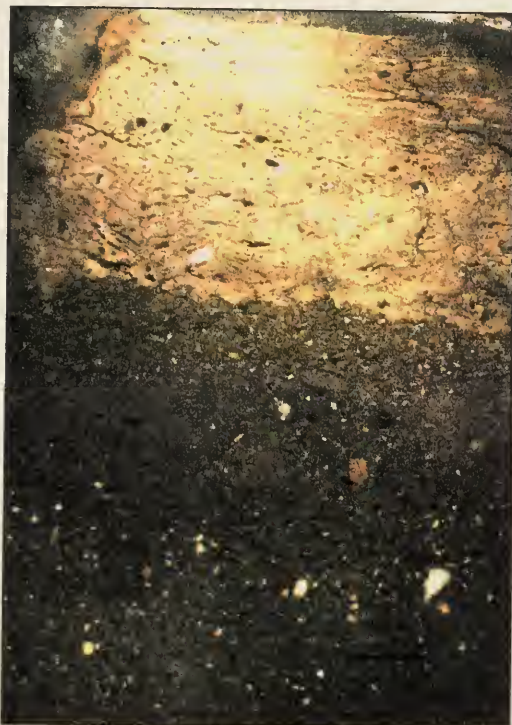
Figure 15: Photomicrograph of cross section D₁ showing full stratigraphy at 5x magnification under quartz halogen illumination. The bar equals 0.5 cm.

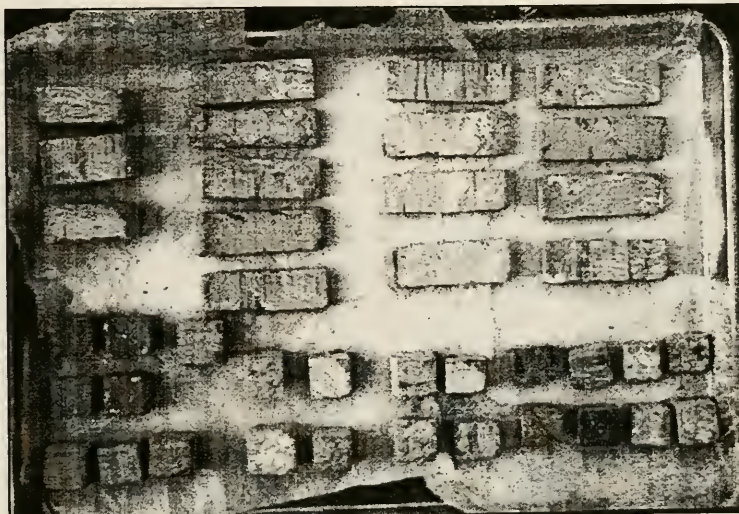
Figure 16: Samples after cutting and before consolidation, used to evaluate the effectiveness of an acrylic resin, epoxy resin, and ethyl silicate polymer.

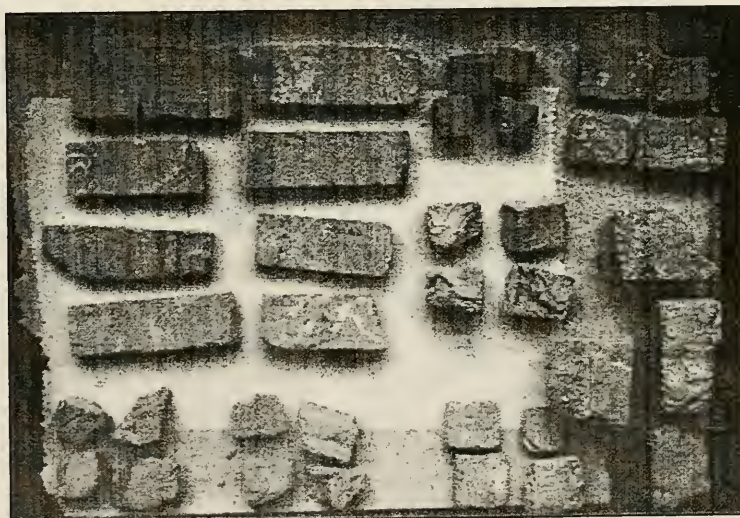
Figure 17: Samples after cutting and before consolidation, used to evaluate the effectiveness of two ethyl silicates, a polymer and monomer, both with and without preconsolidation.

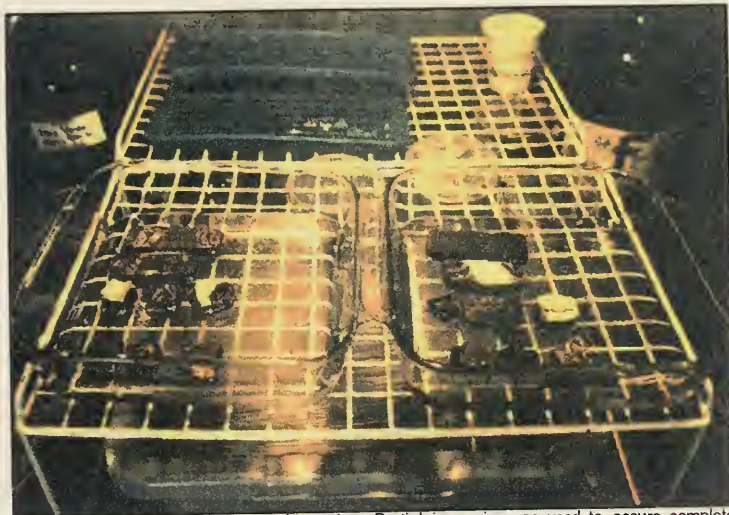
Figure 18: Consolidation by partial immersion. Partial immersion was used to assure complete consolidation and thus comparable test results.

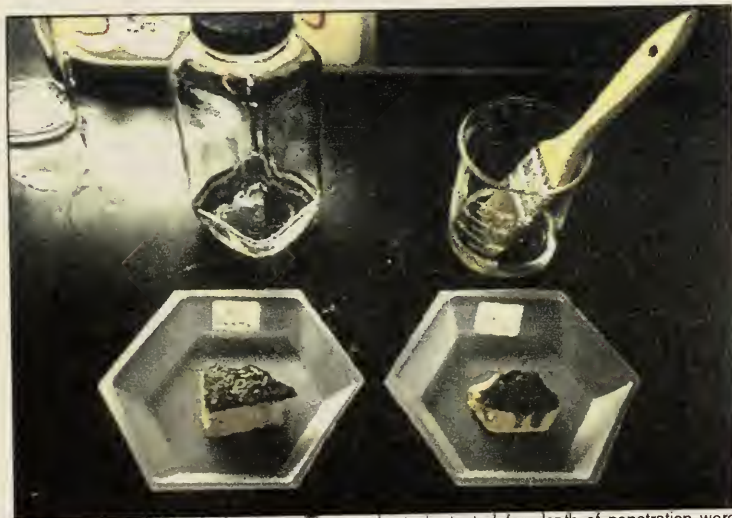
Figure 19: Consolidation by brushing. The samples to be tested for depth of penetration were consolidated by brushing to replicate field application.

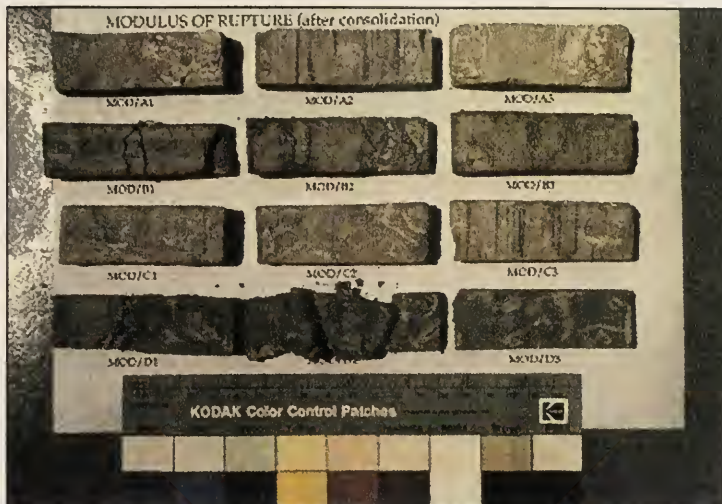
Figure 20: Samples after consolidation. The samples were destroyed by some of the consolidants and could thus not be used for modulus of rupture testing as labeled. They were used to measure abrasion resistance instead.

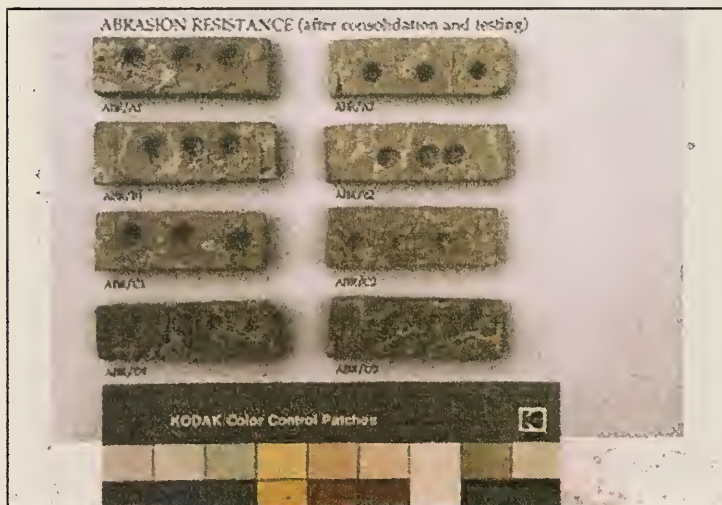
Figure 21: Samples after testing. The samples used to evaluate the increase in resistance to abrasion were put in a chamber and blasted with an abrasive. Each sample was tested three times.

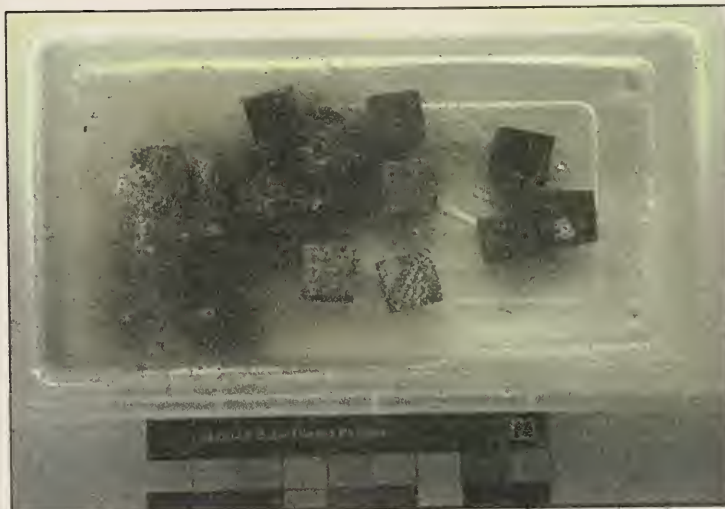
Figure 22: Evaluation of resistance to wet/dry cycling. The unconsolidated samples and some of the consolidated samples, those on the left, deteriorated immediately upon immersion in water.

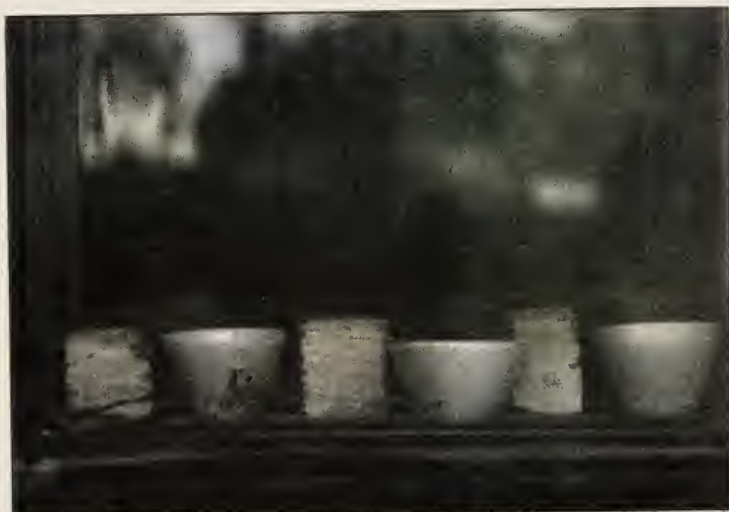
Figure 23: Evaluation of depth of penetration. The reaction of the iodine vapor with the organic material in the consolidant is visible on the sample on the right.

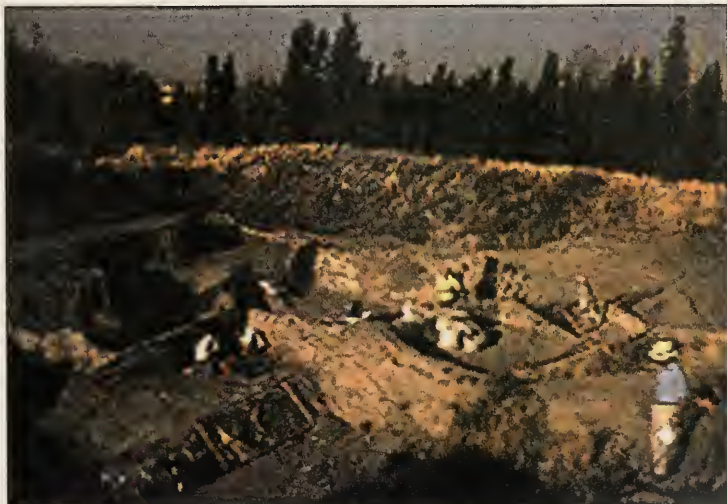
Figure 24: View of the Mellaart Area during the 1996 field season. Excavation is taking place mainly in areas unearthed in the 1960s by James Mellaart.

In the Mellaart Area, the walls of several buildings dating to Mellaart's levels VII and VIII have been unearthed and remain intact. (Figure 24). These are walls composed of mud bricks up to one meter in length and mortar between the bricks. In some cases, the mortar is as thick as the bricks. Based on visual observation, several types of soil have been used to manufacture the mud bricks and mortar. Plaster survives in only a few rooms of the Mellaart Area and is most extensive on the walls of a large open space formed by the joining of two rooms identified as Shrines VII.1 and VII.8 by Mellaart, especially the corner of the south and west walls of Shrine VII.1 and the east wall of Shrine VII.8.

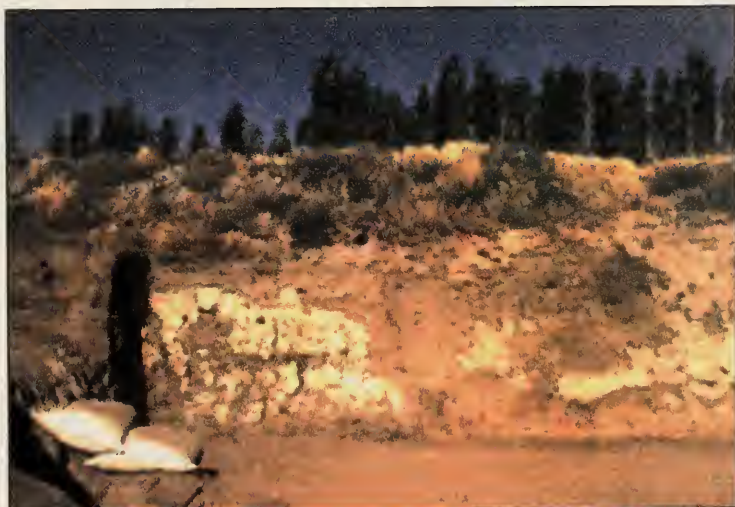
Figure 25: West wall of Shrine VII.1 showing condition of plaster and location of trial preconsolidation tests.

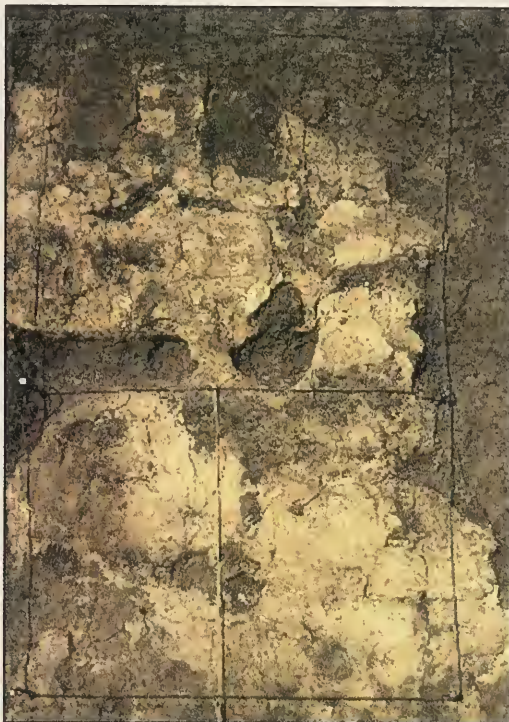
Figure 27: West wall of Shrine VII.1 after preconsolidation and consolidation field testing. The area that has been preconsolidated, the upper rectangle and the right half of the lower rectangle, are slightly discolored.

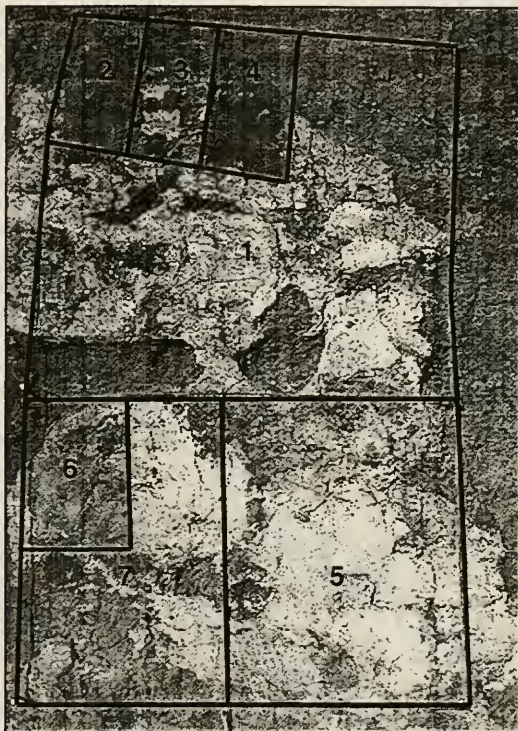
Figure 28: Test sections on west wall of Shrine VII.1.

Section	Treatment	Results
1	preconsolidant: Aquazol 50/T1919 mixture sprayed in one application consolidant: T1919 sprayed on in 15 cycles over 5 days (3 cycles/day)	slight darkening negligible to slight strengthening of plaster
2	preconsolidant: A-50/T1919 mixture sprayed in one application followed by B-72 (7% in xylene) brushed on consolidant: T1919 sprayed on in 15 cycles over 5 days (3 cycles/day)	significant darkening moderate strengthening of plaster
3	preconsolidant: A-50/T1919 mixture sprayed in one application followed by B-72 (7% in xylene) sprayed on consolidant: T1919 sprayed on in 15 cycles over 5 days (3 cycles/day)	significant darkening moderate strengthening of plaster
4	preconsolidant: A-50/T1919 mixture sprayed in one application followed by Aquazol 50 (5% in ethanol) brushed on consolidant: T1919 sprayed on in 15 cycles over 5 days (3 cycles/day)	significant darkening moderate strengthening of plaster

Delaminated and extremely friable plaster requires preconsolidation as an initial stabilization effort. (Figures 28 and 29). Consolidation generally will not increase the adhesion between plaster layers or between paint layers and plaster. Thus, a preconsolidant which acts as an adhesive is desirable. In addition, plaster in a severely deteriorated state may be too fragile to treat without preconsolidation. Preconsolidation consists of the application of a liquid material onto plaster or other porous material. In the case of the treatment of the Çatalhöyük plasters, the preconsolidant has several functions. The preconsolidant rehydrates the plaster so that delaminating strata can be manipulated during excavation. It also gives some cohesive strength to the plaster so that it is more

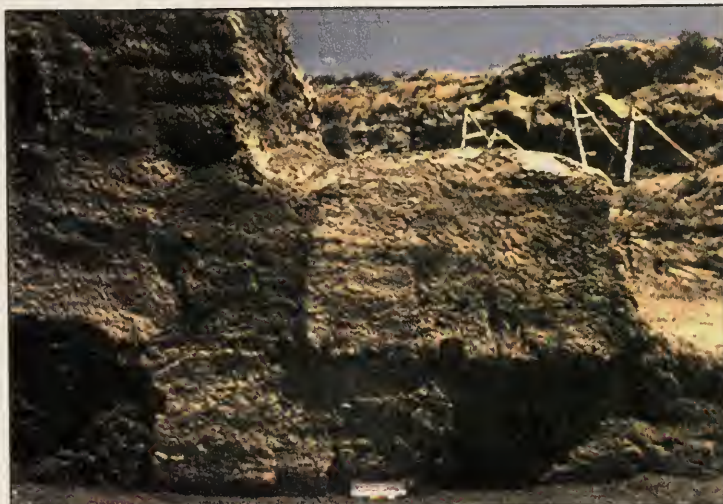
Figure 29: East wall of Shrine VII.8 showing extent of intact plaster and location of trial preconsolidation tests.

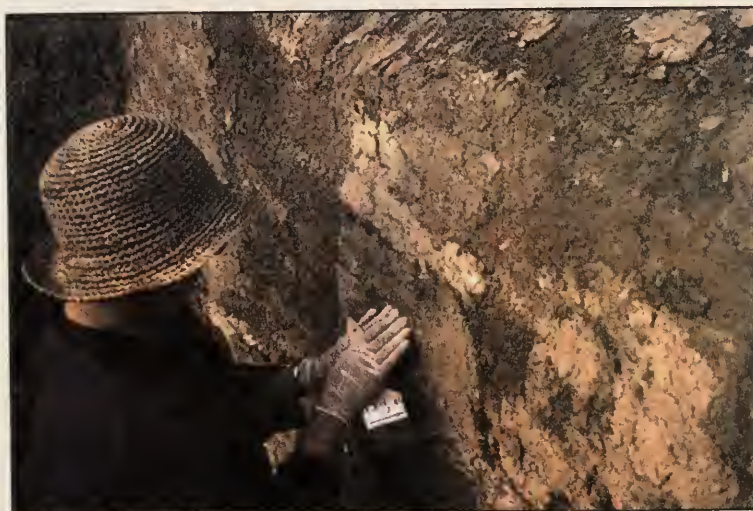
Figure 30: Constance Silver applying preconsolidant to the surface of the east wall of Shrine VII.8 in order to stabilize the plaster.

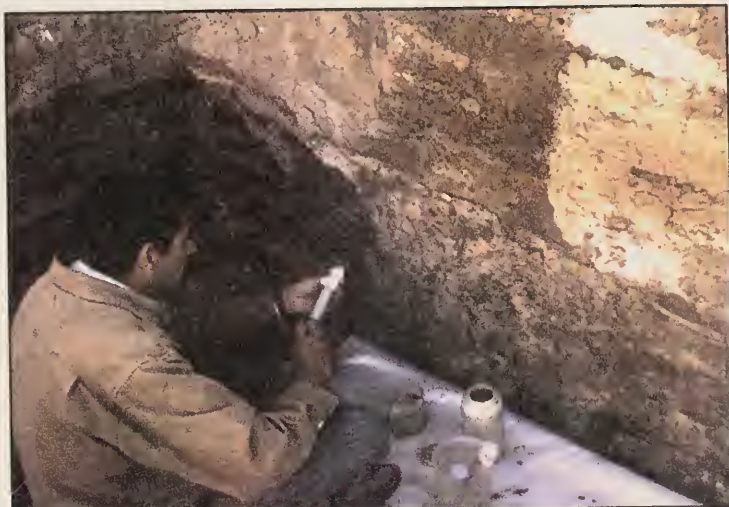
Figure 31: Frank Matero injecting grout behind the lower sections of the east wall of Shrine VII.8 in order to reattach detached pieces of plaster.

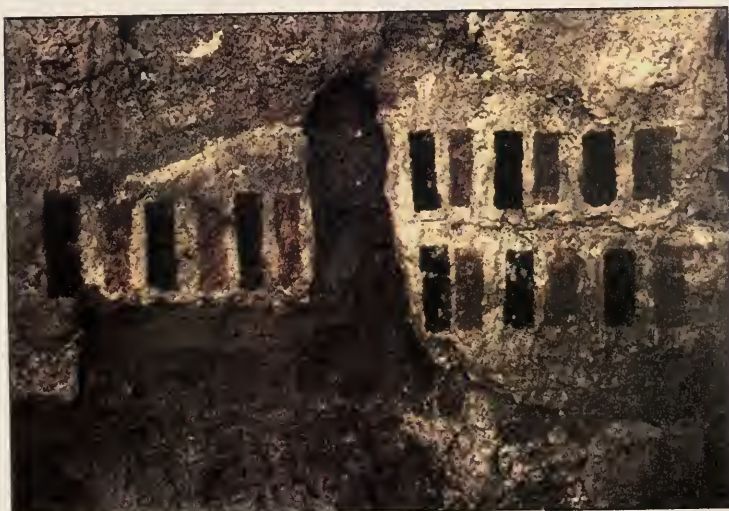
Figure 32: Test area painted with watercolors to evaluate the effects of the tested treatments on wall paintings.

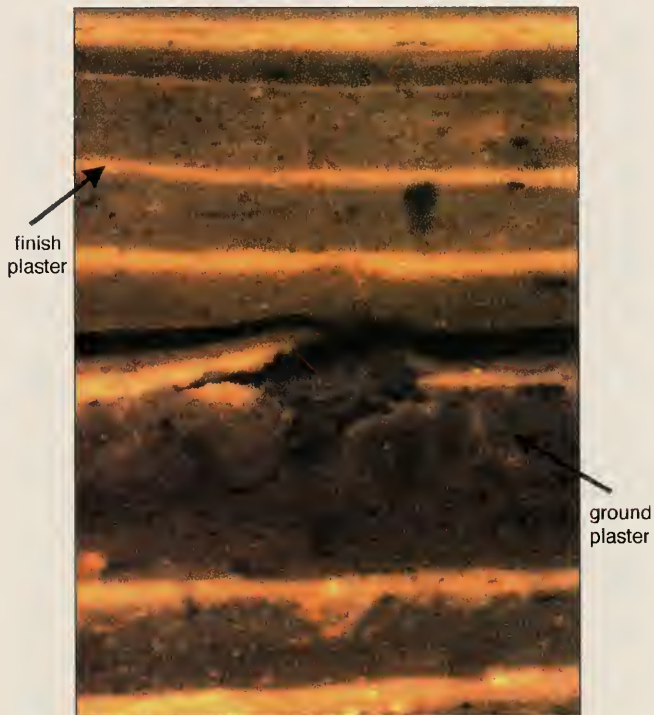
Figure 33: Photomicrograph of cross section A1 showing typical plaster layers and crack along the layers. 62.5x magnification under reflected quartz halogen illumination.

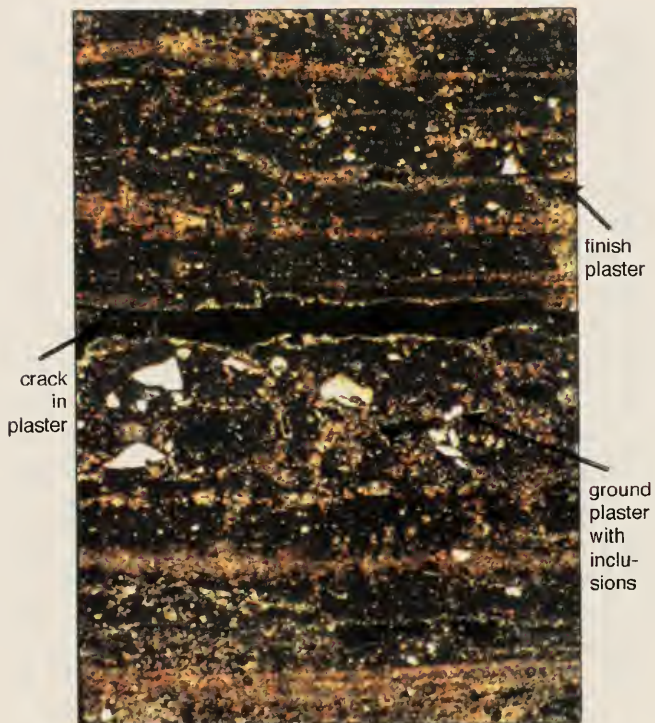
Figure 34: Photomicrograph of thin section A2 showing coarse-sized mineral inclusions in ground layer under crack. 50x magnification under transmitted cross-polarized light.

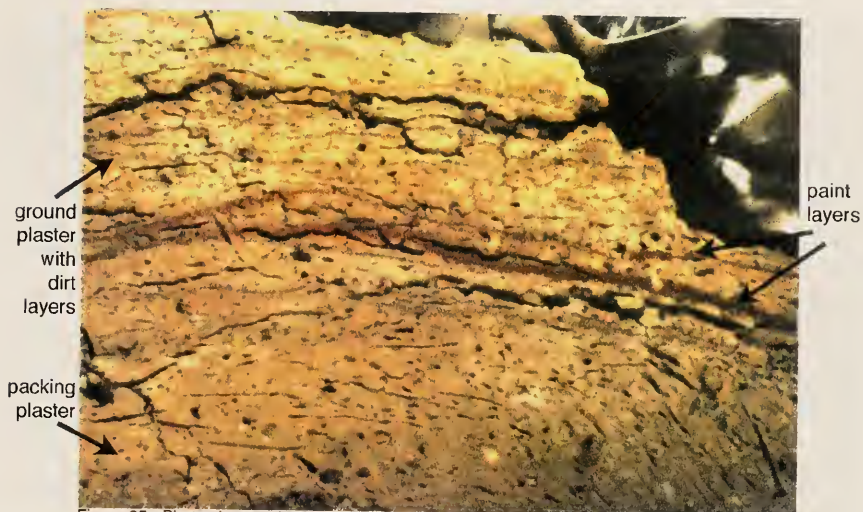
Figure 35: Photomicrograph of cross section B1 showing ground plaster and paint layers of a plaster relief. 9.5x magnification under reflected quartz halogen illumination.

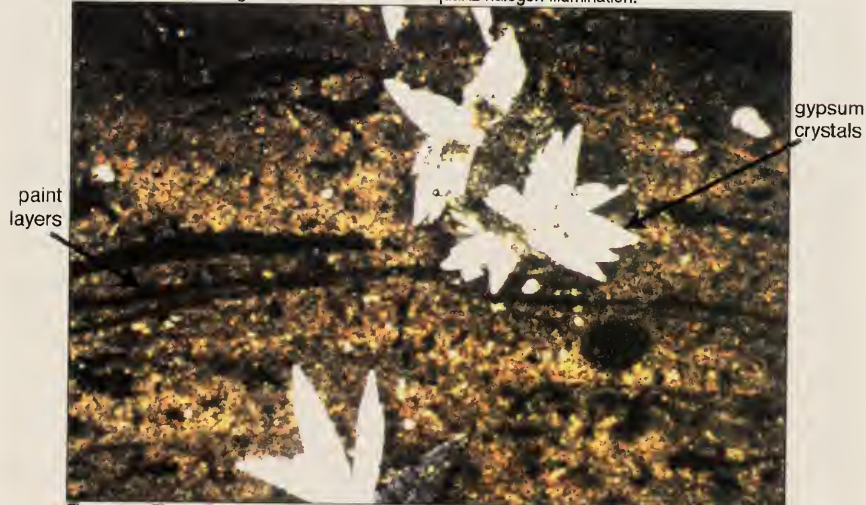
Figure 36: Photomicrograph of thin section B2 showing gypsum crystals associated with paint layers. 50x magnification under transmitted cross-polarized light.

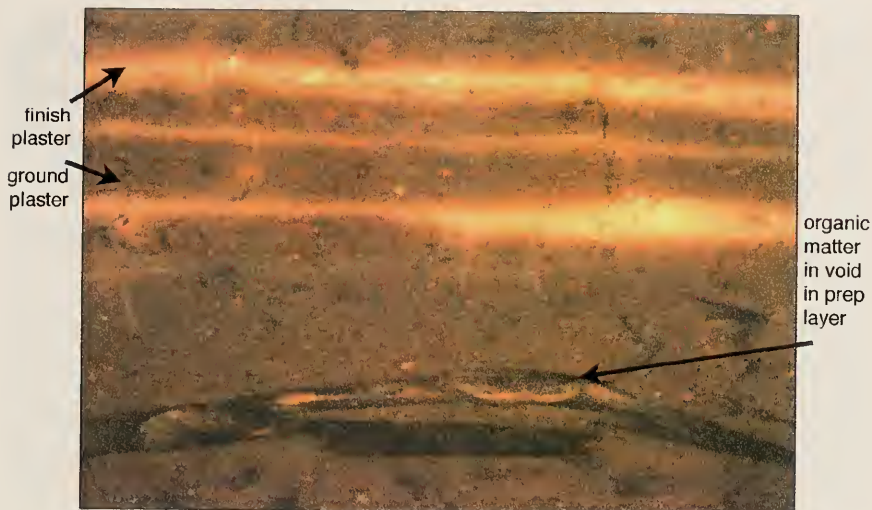
Figure 37: Photomicrograph of cross section C1 showing the preparatory layer and subsequent plaster layers of a wall plaster. 62.5x magnification under reflected quartz halogen illumination.

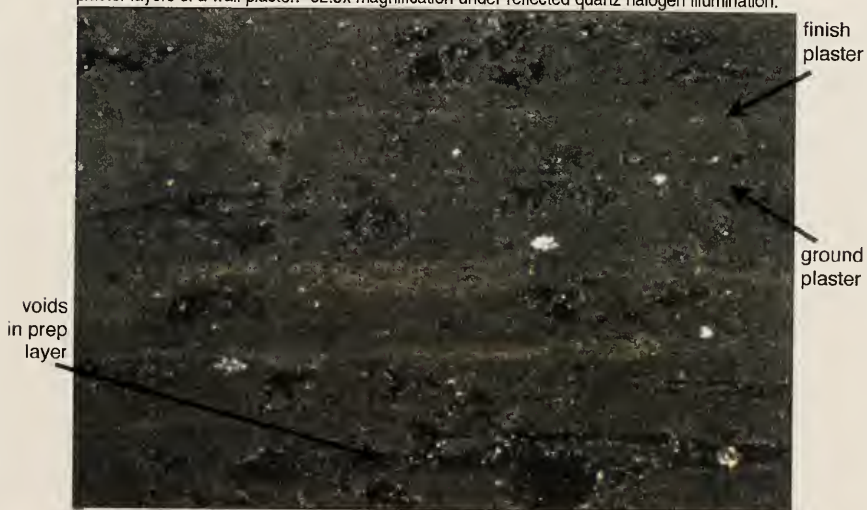
Figure 38: Photomicrograph of thin section C2 showing the absence of coarse-size particles in the ground and finish layers. 50x magnification under transmitted cross-polarized light.

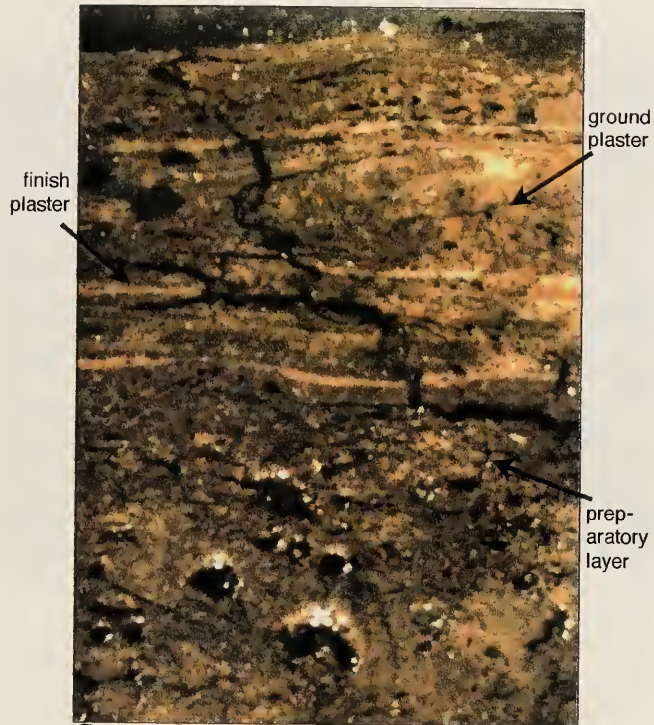
Figure 39: Photomicrograph of cross section D1 showing the preparatory layer and subsequent plaster layers of a wall plaster. 17.5x magnification under reflected quartz halogen illumination.

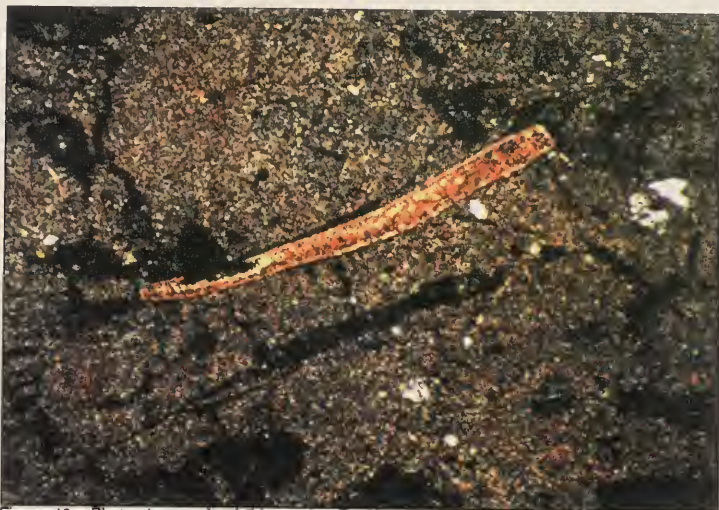
Figure 40: Photomicrograph of thin section D2 showing an unburned shell in the preparatory coat of the plaster. 50x magnification under transmitted cross-polarized light.

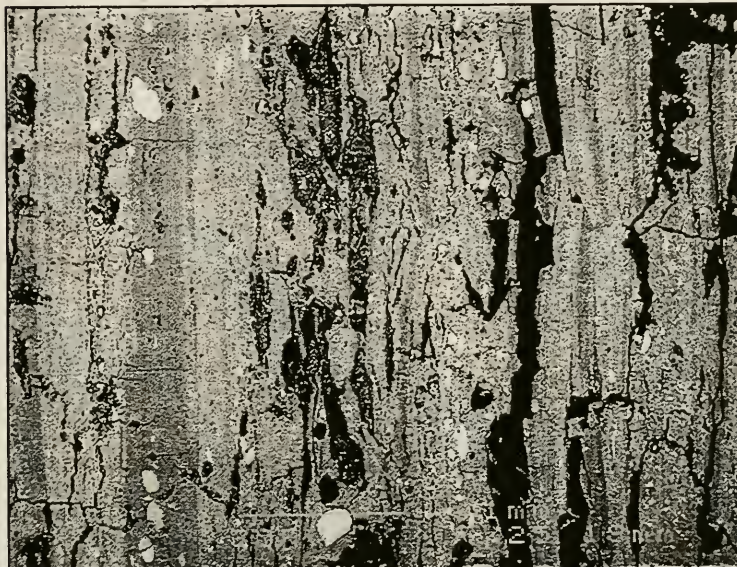
Figure 41: Back-scattered electron image of cross section A1 showing finish plaster (dark vertical areas), ground plaster (light vertical areas) and cracks and voids (black areas). 25x magnification.

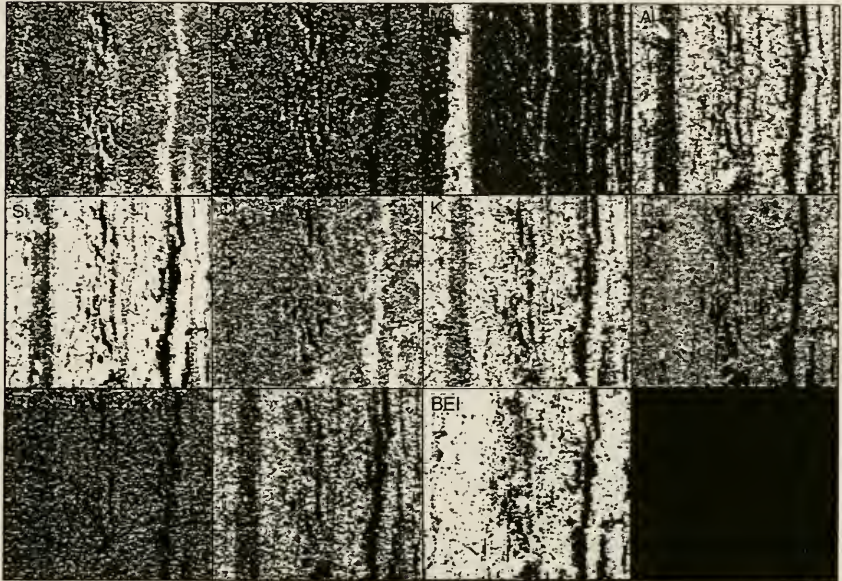
Figure 42: X-ray dot map of figure 40 showing the position of the principle elements in cross section A1. The elements are (upper row, left to right) carbon, oxygen, magnesium, aluminum, (middle row, left to right) silicon, chlorine, potassium, calcium, (bottom row, left to right) titanium, iron, and back-scattered electron image. The finish plaster layers have a relatively high amount of magnesium, whereas the ground plaster has more aluminum and potassium than the finish layers. Calcium is fairly evenly distributed between the two types of plaster and is probably mostly grouped with carbonate to form calcium carbonate.

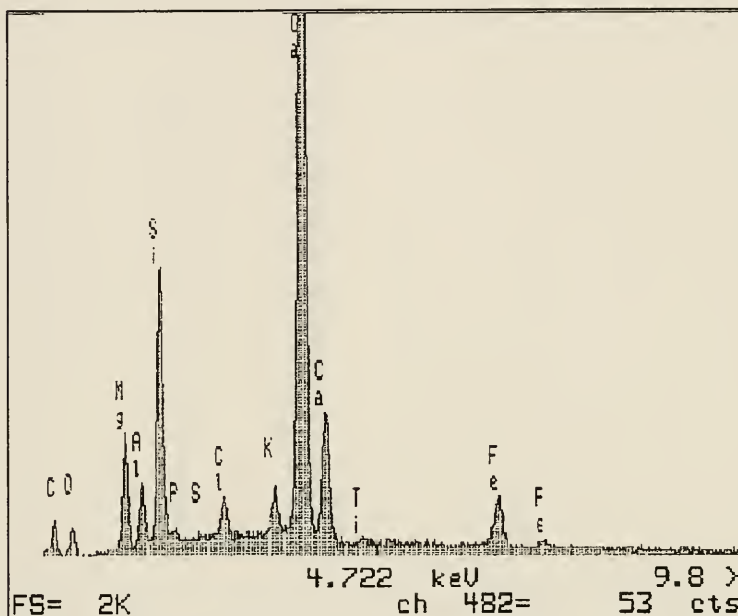
Figure 43: EDS spectrum of a finish plaster layer in cross section A1. The predominant element is calcium, which most likely occurs as calcium carbonate. There is also a relatively large amount of silicon, which may be part of silica quartz or a clay, and magnesium, which may also be attached to a clay.

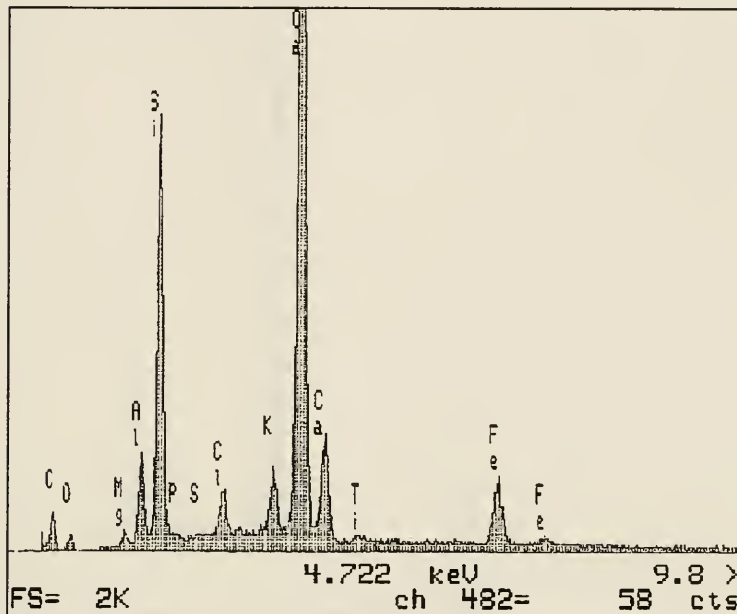
Figure 44: EDS spectrum of a ground plaster layer in cross section A1. Like the finish plaster, the ground plaster has a large amount of calcium and silicon, but it has much less magnesium, relatively.

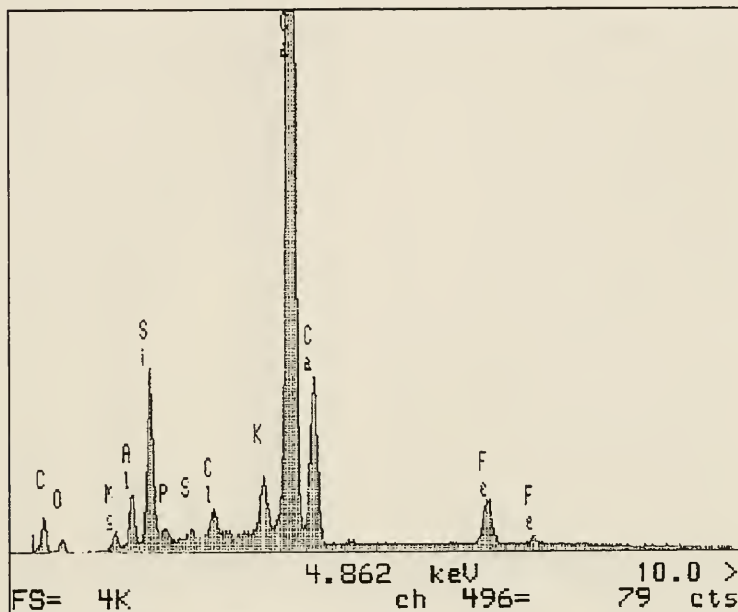
Figure 45: EDS spectrum of the preparatory plaster layer of cross section A1. The preparatory plaster is very similar in relative composition to the ground plaster.

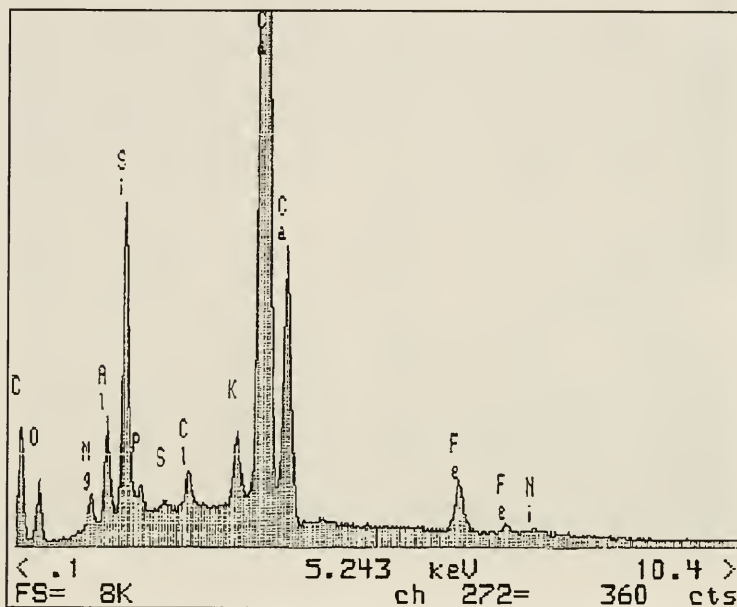
Figure 46: EDS spectrum of a finish plaster layer in cross section C1. Unlike the finish plaster of sample A, the finish plaster of sample C has relatively little magnesium, and is thus more similar to the ground and preparatory plasters based on elemental composition.

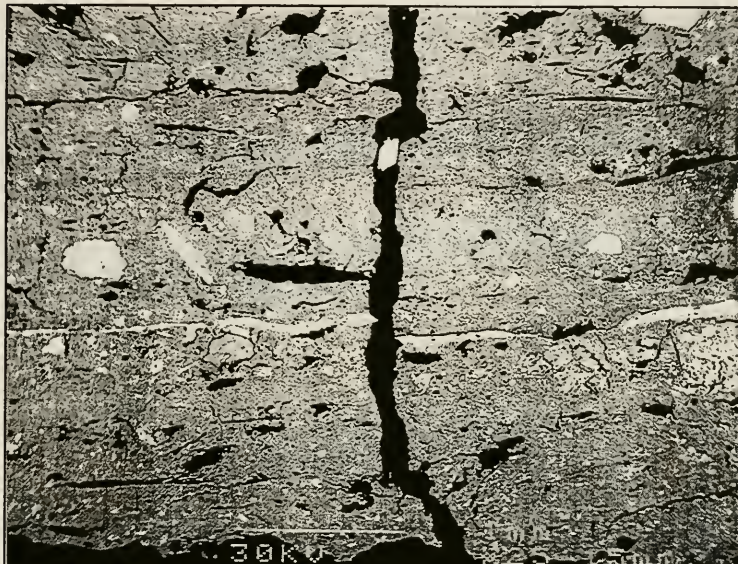
Figure 47: Back-scattered electron image of cross section B1 showing paint layer (light horizontal band) and cracks and voids (black areas). The edge of the relief plaster is at the bottom of the image. 25x magnification.

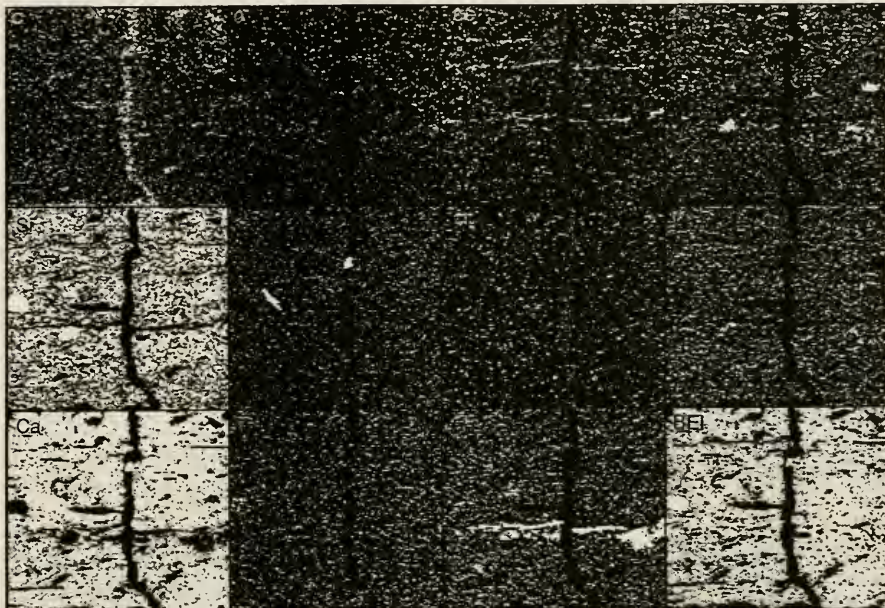
Figure 48: X-ray dot map of figure 47 showing the position of the principle elements in cross section B1. The elements are (upper row, left to right) carbon, oxygen, magnesium, aluminum, (middle row, left to right) silicon, sulfur, chlorine, potassium, (bottom row, left to right) calcium, titanium, iron, and back-scattered electron image. The finish plaster layers have a relatively high amount of magnesium and the paint layer is rich in iron. The round blebs which are bright white in the window for silicon are most likely quartz particles. The white areas in the sulfur window may be gypsum crystals.

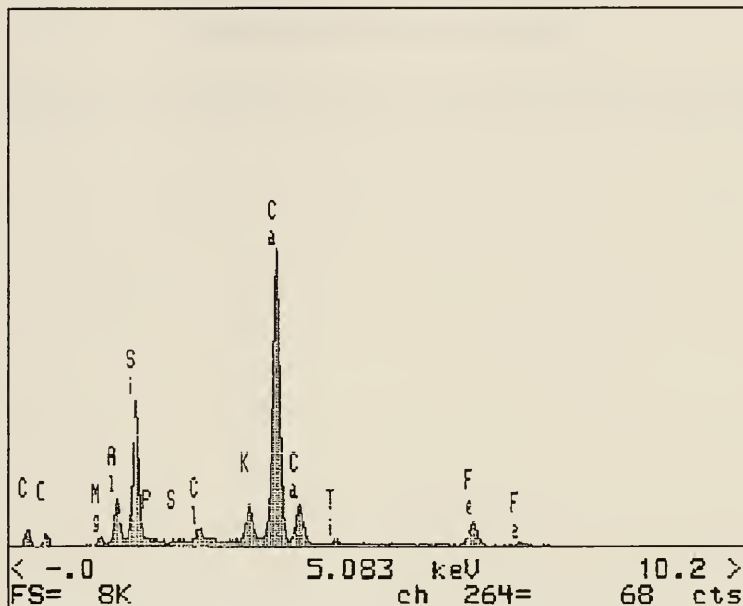
Figure 49: EDS spectrum of a ground plaster layer in cross section B1. The relative intensities of the elemental peaks are nearly identical to the intensities of the peaks for the ground plaster in sample A.
